## CASE REPORT

# Gross Trunnion Failure in Recalled Femoral Head in Total Hip Arthroplasty

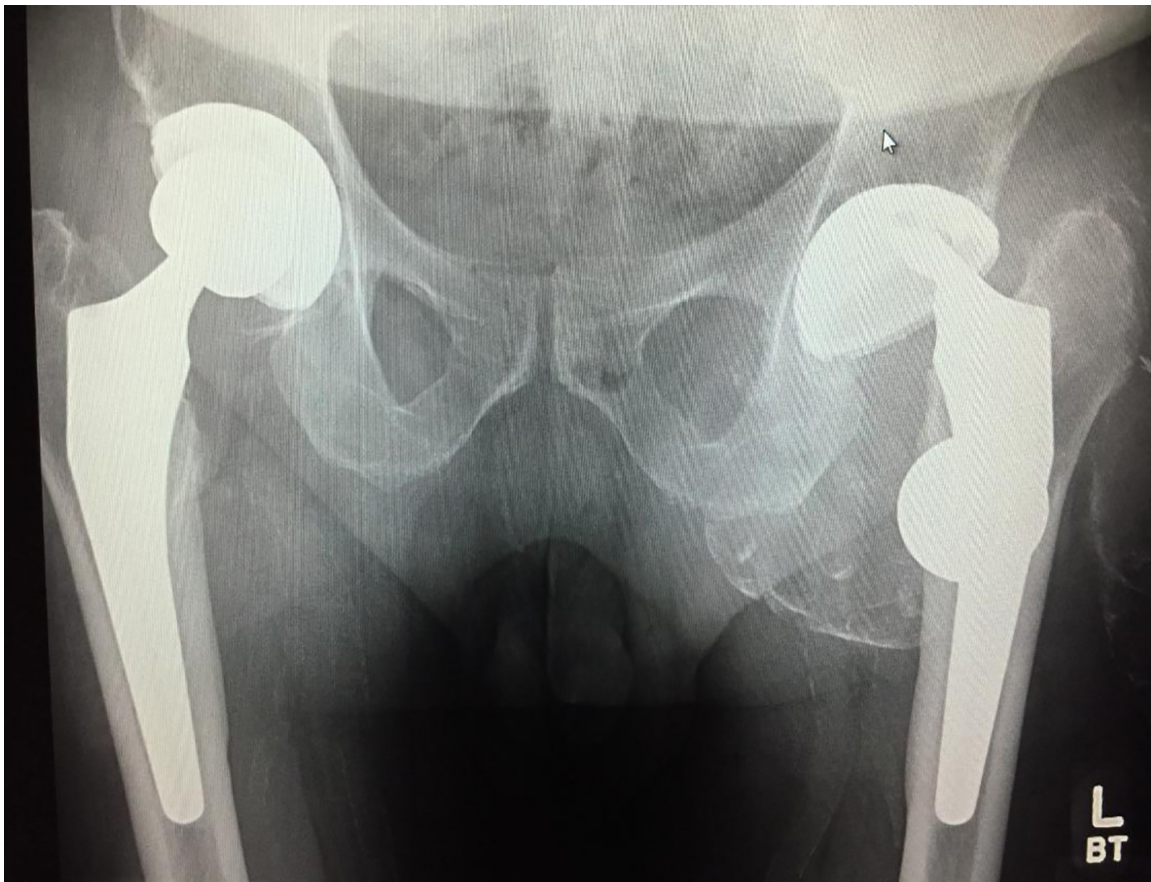
in August 2007 and right THA in February 2008. Stryker Low Friction Ion Treatment (LFIT) V40 implants were used in both operations. Subsequent radiographic work up at present time, demonstrated left femoral head dissociation from the trunnion with extensive trunnionosis as well as metallosis surrounding his left hip (Figure 1). On exam, patient was found to have painful range of motion about his left hip as well as grinding and crepitus. His left leg was found to be 1 cm shorter than the right.

**Figure 1.** Plain radiograph demonstrating left femoral head dissociation from the trunnion with extensive trunnionosis as well as metallosis surrounding his left hip.

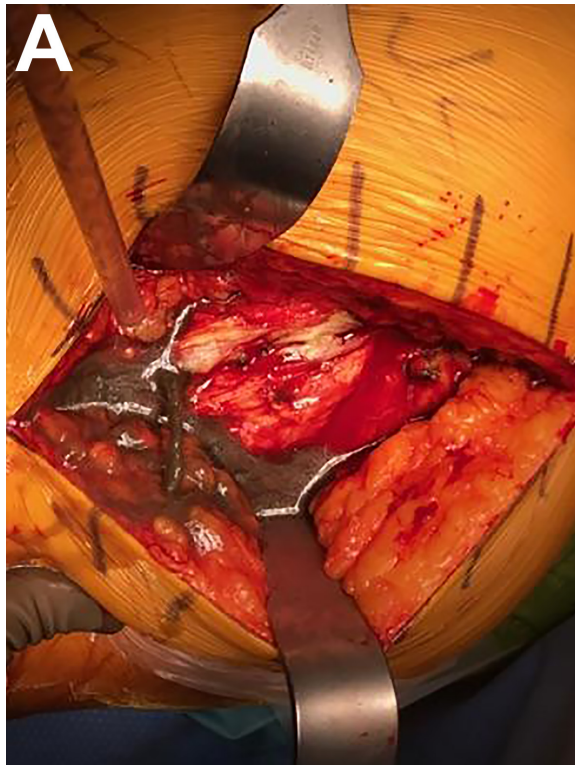
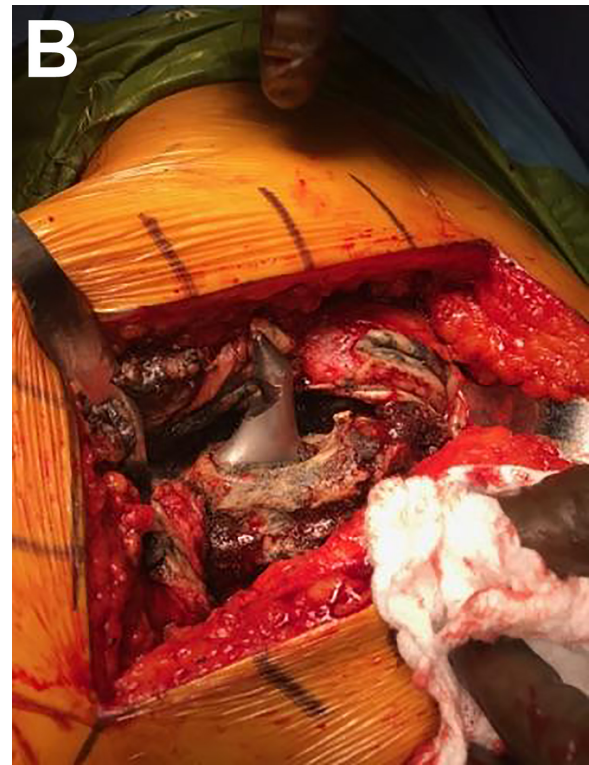
The patient underwent left hip THA revision August 2017. The hip was approached through an anterolateral incision. Upon entering the joint space, a metal-stained joint fluid was encountered with notable fretting about the trunnion

**Figure 2.** Intraoperative images revealing metal-stained fluid (A) and issue around the trunnion (B) consistent with metallosis.

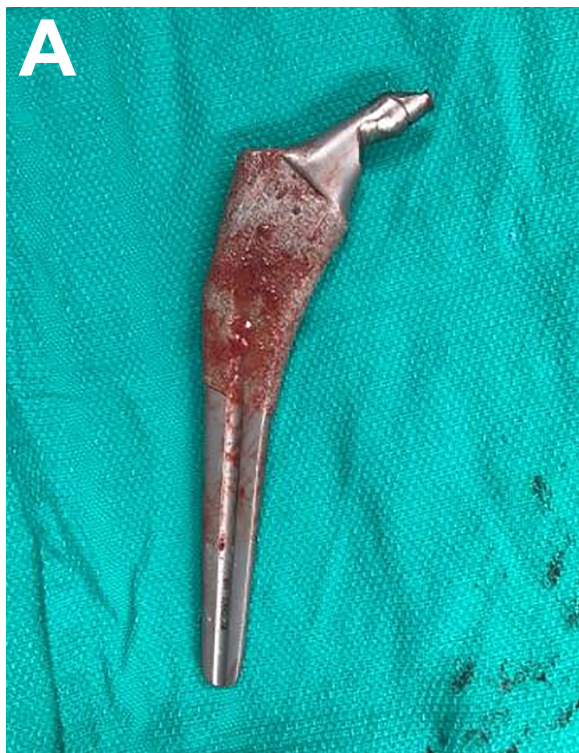
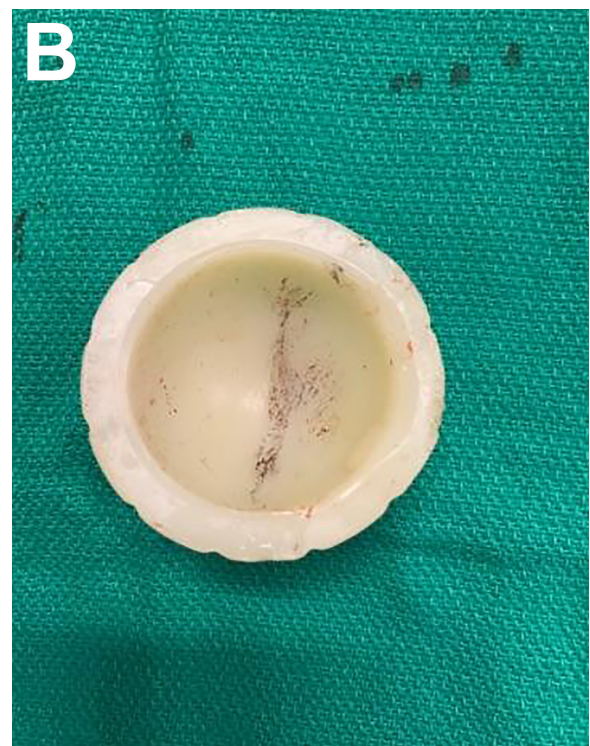
and significant damage to the acetabular liner (Figure 2 and 3). The femoral head was lo-

**Figure 3.** Retrieved THA components demonstrated notable fretting about the trunnion (A) and a significant damage to the acetabular liner (B)

loosening occurs at the junction of the modular components, crevice corrosions may also cause detrimental mechanical failure of the implant [1]. In the case of our patient's recalled implants, the metal head was milled with a morse taper slightly too large for the trunnion. This resulted in micromotion between implants and ultimate fretting until catastrophic failure.

and lateral two-thirds of the hip capsule rendering the abductors incompetent (Figure 4). The patient's construct was revised using a constrained liner, the addition of two 6.5-mm dome screws as well as a size 13 lateralized cemented stem and a 28 mm standard head.

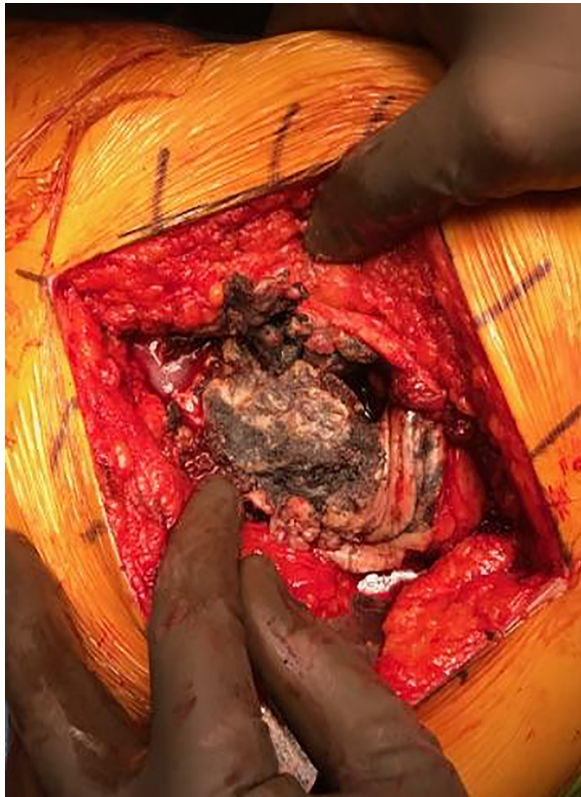
**Figure 4.** Extensive metallosis around the hip capsule.
